**INSTALLATION RESTORATION PROGRAM  
CLOSURE INVESTIGATION REPORT  
SITE 1 - FORMER BASE LANDFILL**

**STEWART AIR NATIONAL GUARD BASE  
NEWBURGH, NEW YORK**

**APRIL 1997**

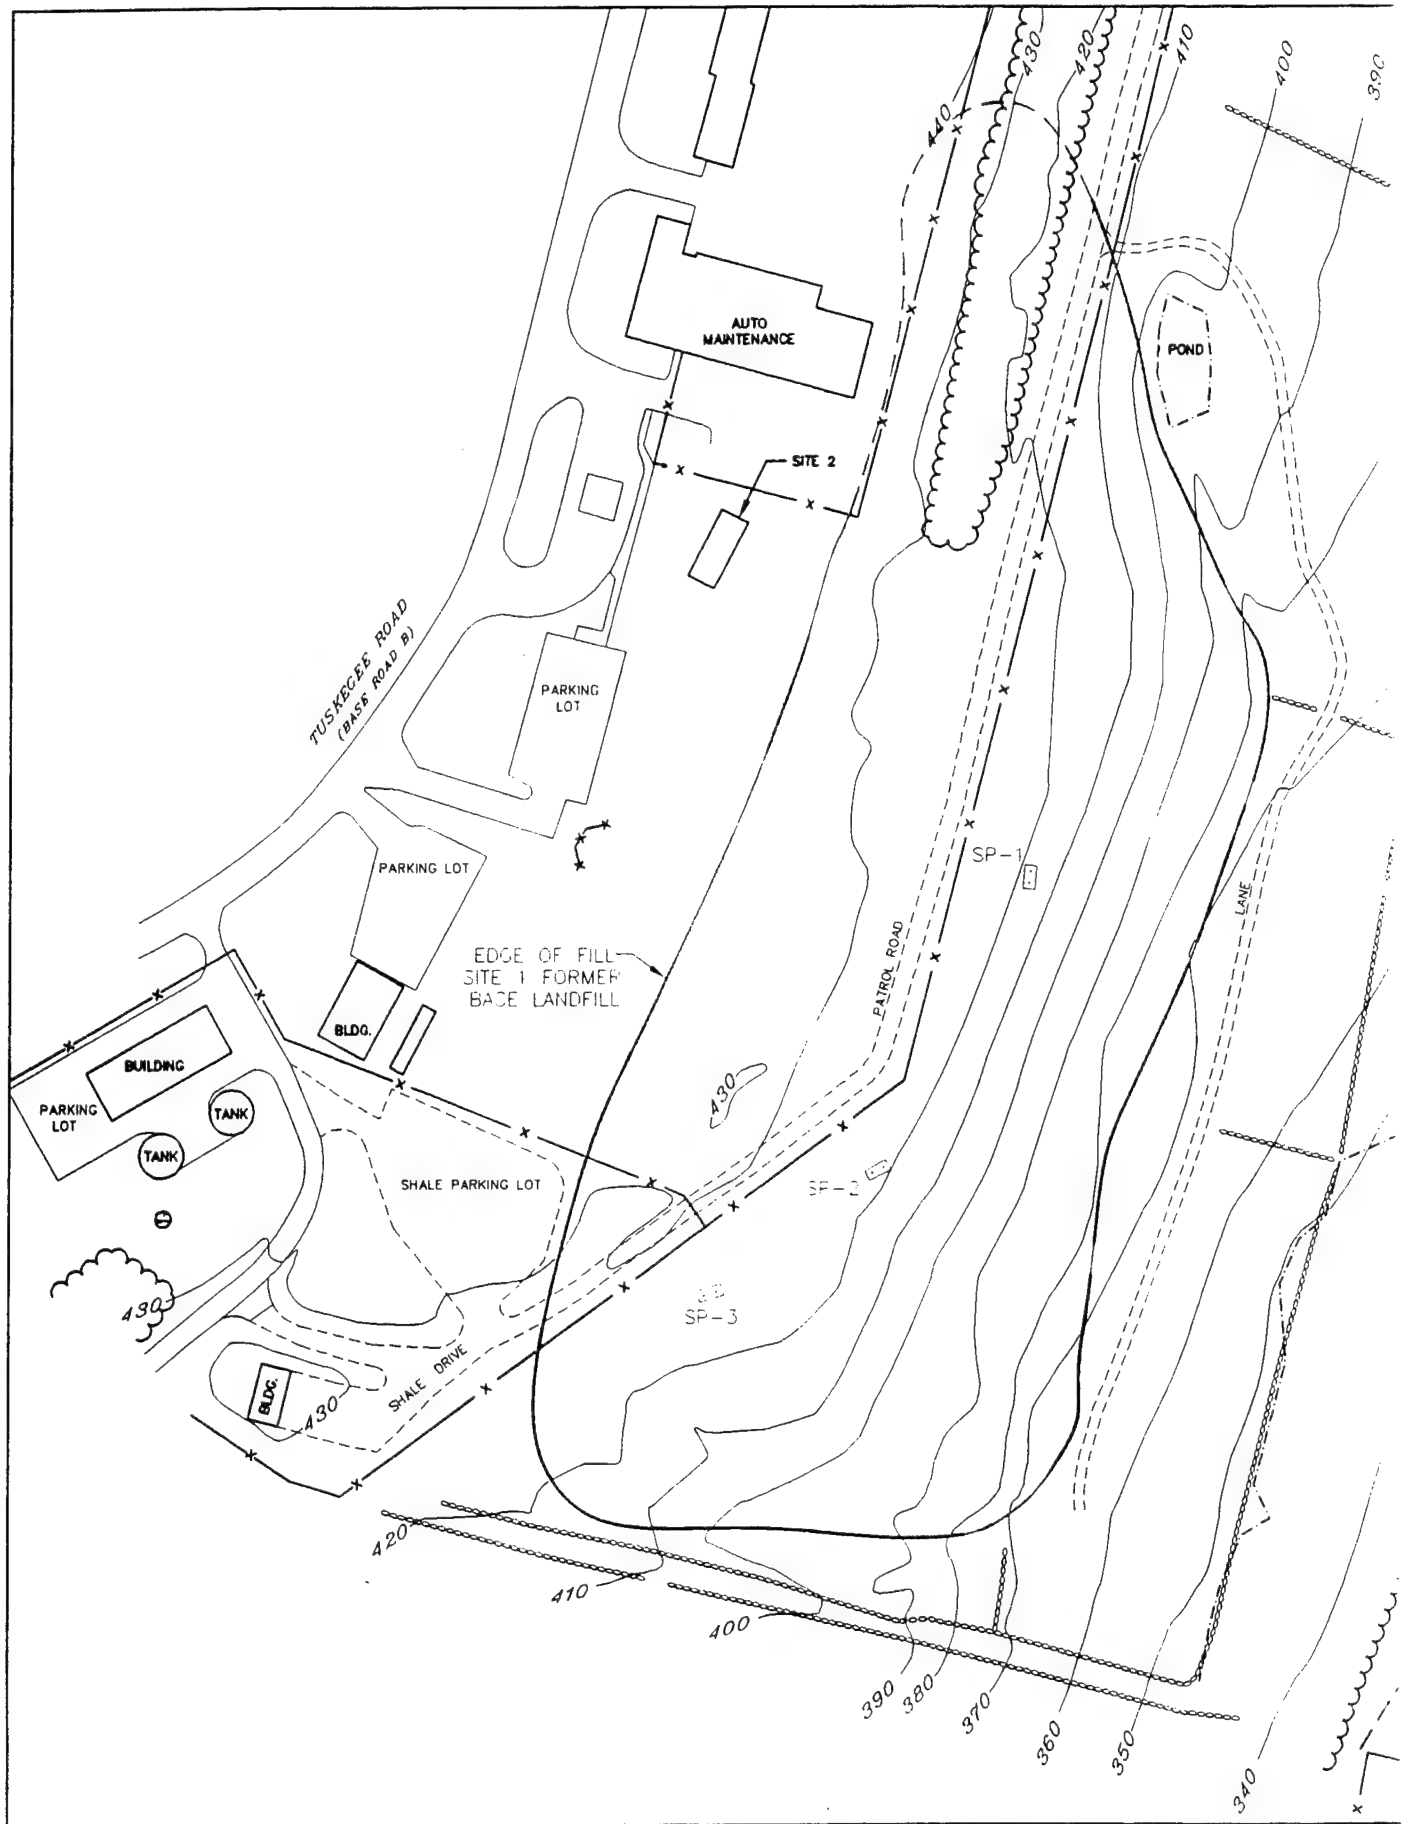
TITLE		FIGURE 4-3 SETTLEMENT PAD LOCATION	
PREPARED FOR		STEWART AIR NATIONAL NEWBURGH, NEW YORK	
DATE		APRIL 15, 1997	
SOURCE		GREVAS & HILDRETH, P.C. LAND SURVEYORS	
JOB NO.		SHEET

Three concrete settlement pads were constructed near the top break in the landfill slope. Each pad was constructed of cast-in-place concrete with two steel pipe risers as described in the Work Plan (ANEPTEK, 1995b). Figure 4-3 presents the settlement pad locations. The same control points and coordinate system set up for the slope stability monuments was used to monitor the
